Kynance Gate Prehistoric Settlement Management Plan

A Monumental Improvement Project

Cornwall National Landscape

September 2025

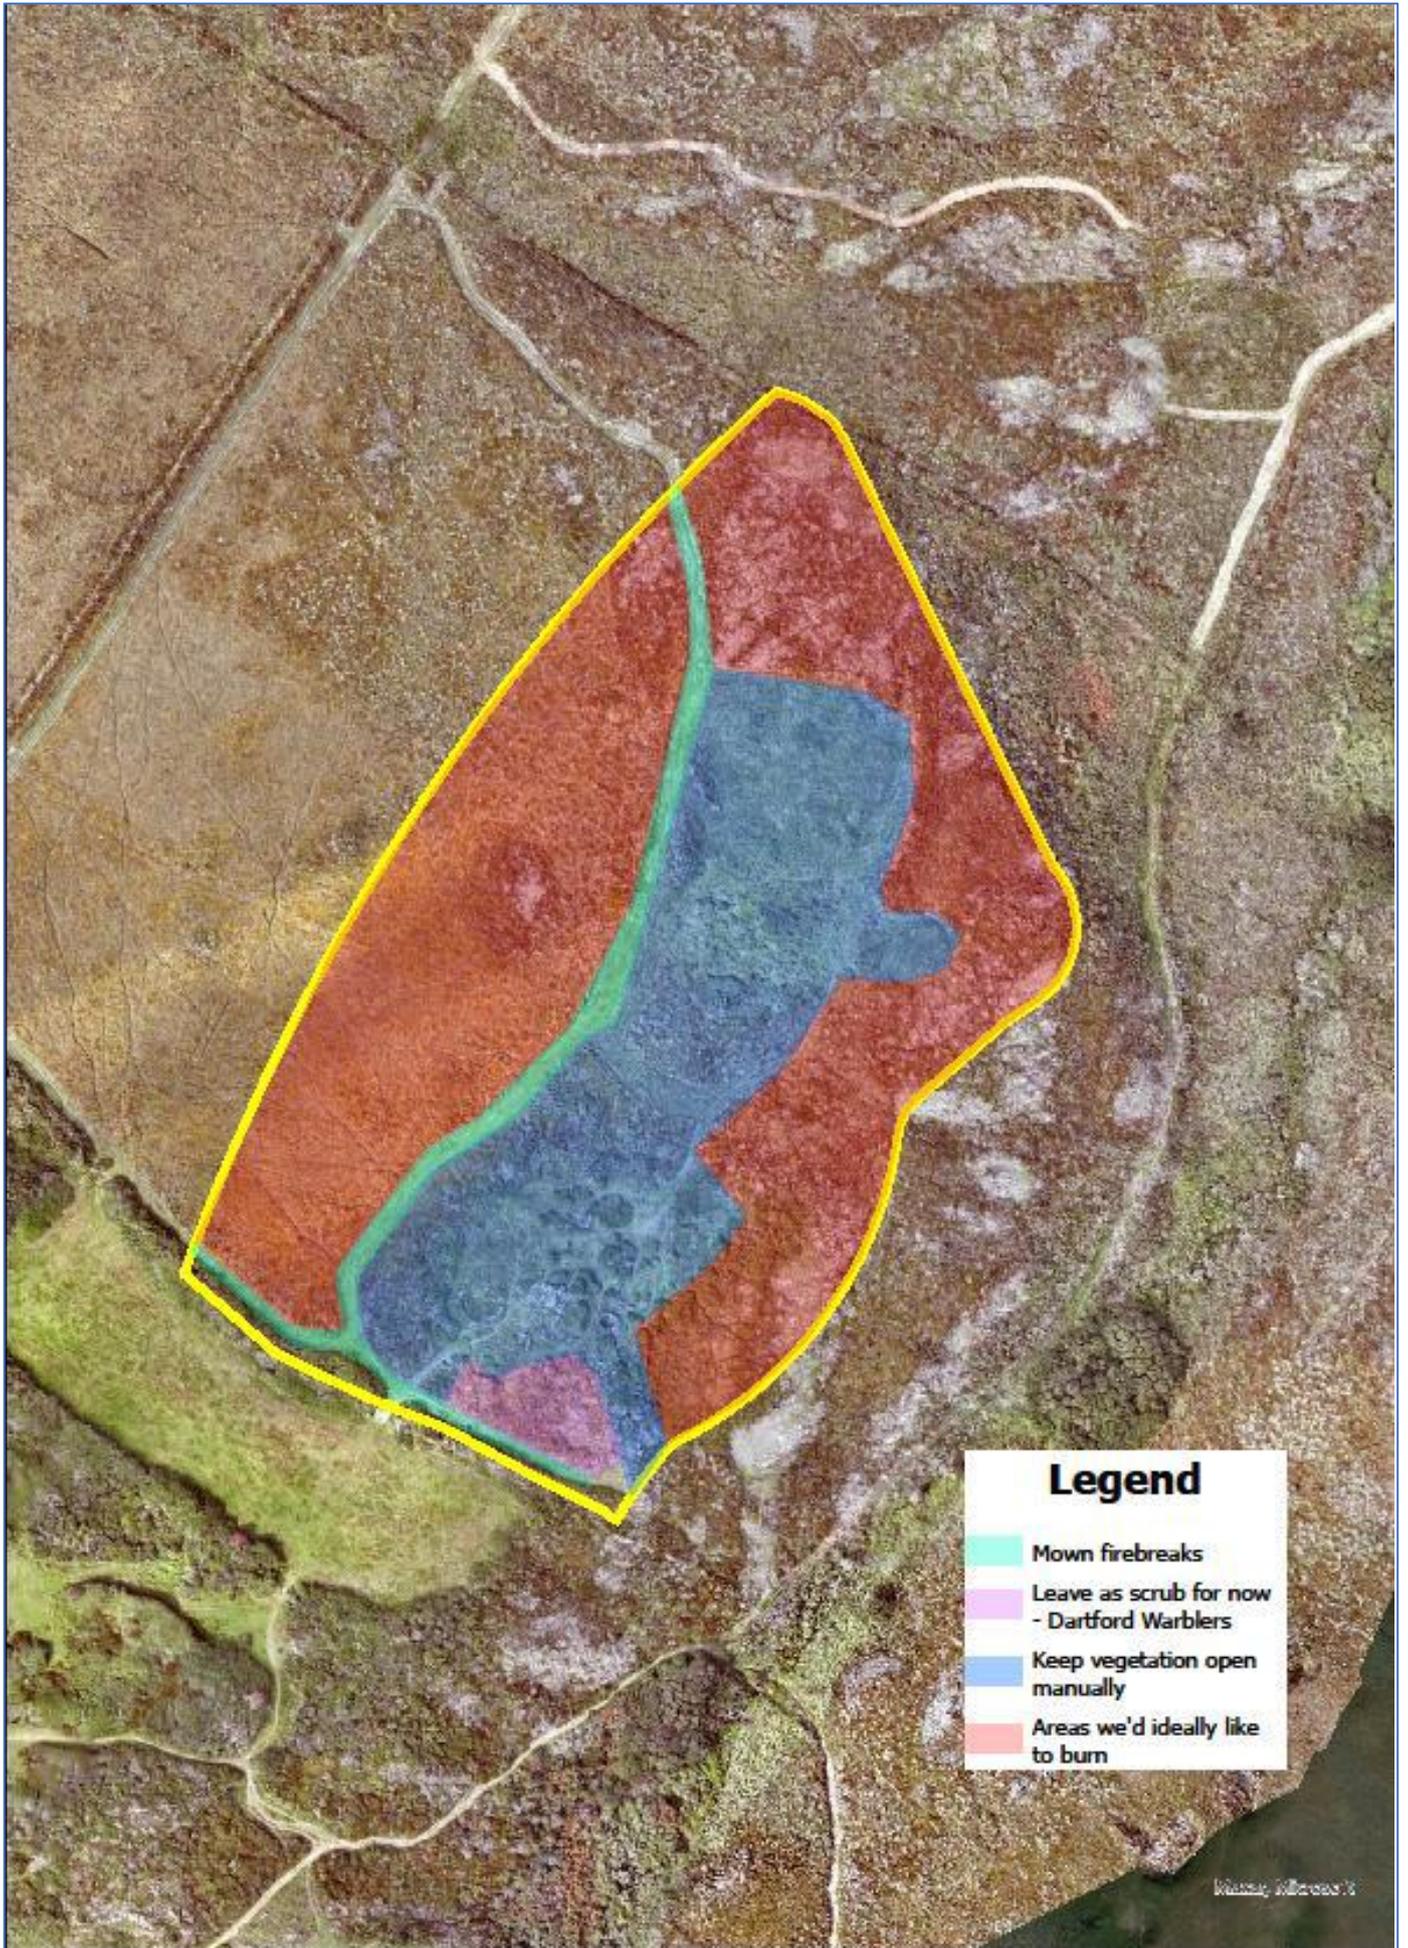
- In collaboration with the landowner, the Relevant Volunteer Organisation should aim to hold two hand tools vegetation clearance events per year, focussing on the southern group and keeping the site accessible to the public. The below graphic produced by Natural England shows the areas targeted for 'cool burning' in red, and hand tools (manual) clearance in blue.
- This methodology has been approved by Historic England for managing vegetation at this site.
NB: The purple area of scrub can be cleared once Natural England confirm the area is no longer suitable for Dartford Warblers, who prefer to nest in low gorse and will vacate once the gorse matures.

- Mown firebreaks
- Leave as scrub for now - Dartford Warblers
- Keep vegetation open manually
- Areas we'd ideally like to burn

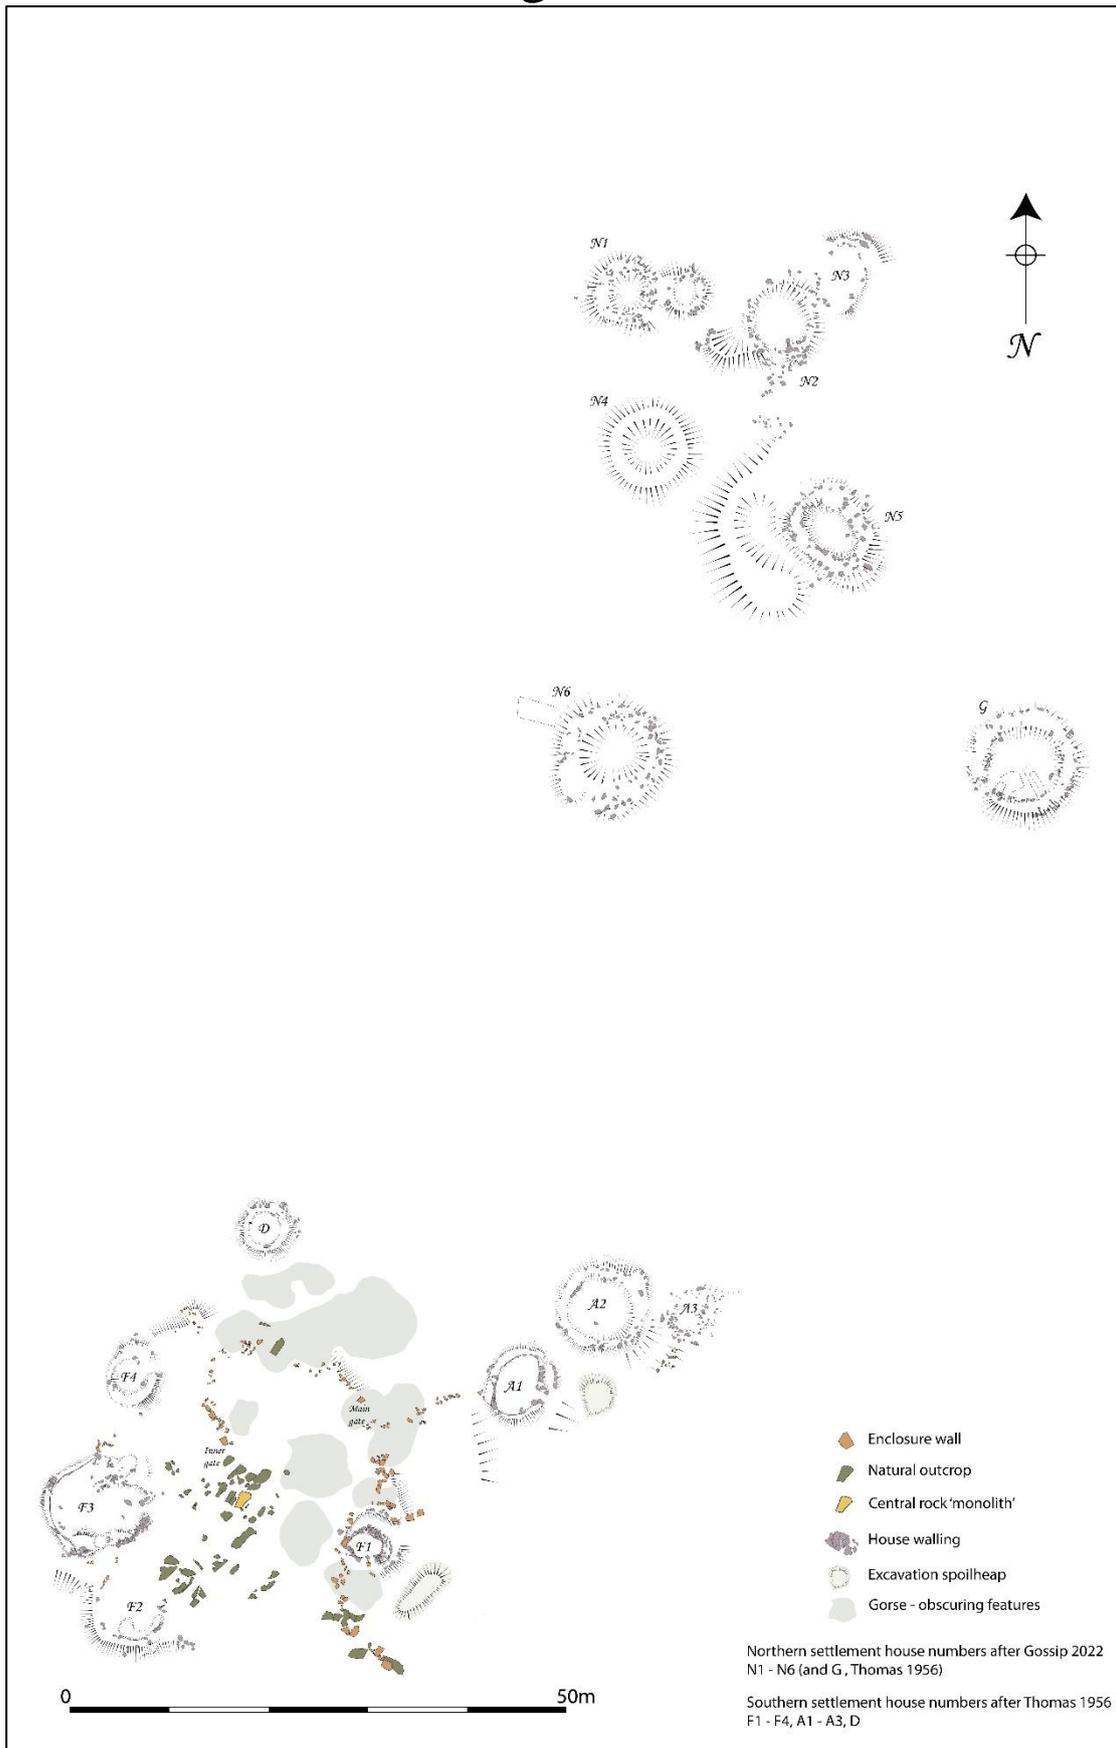
Fig 1. J.Gossip CAU 2024 survey of roundhouses at Kynance Gate

The monument includes a stone hut circle settlement with an associated irregular aggregate field system, situated on the edge of an open moorland plateau around a rocky spur on the north-western side of the steep valley leading to Kynance Cove. The settlement survives as two discreet groups of stone hut circles with associated small fields defined by stone walls. The north-eastern group includes possibly seven circular or slightly oval shaped stone hut circles measuring 9m in diameter on average and surrounded by walls of up to 0.4m high, with various attached enclosures. These have been partly surveyed by Total Station and GPS as part of the current project (Fig 2). The south-western group includes at least nine circular or oval stone hut circles defined by thick double-faced walls and all linked together by boundaries to form at least three enclosures. All the buildings in the southern group are constructed on a raised, terraced platform.

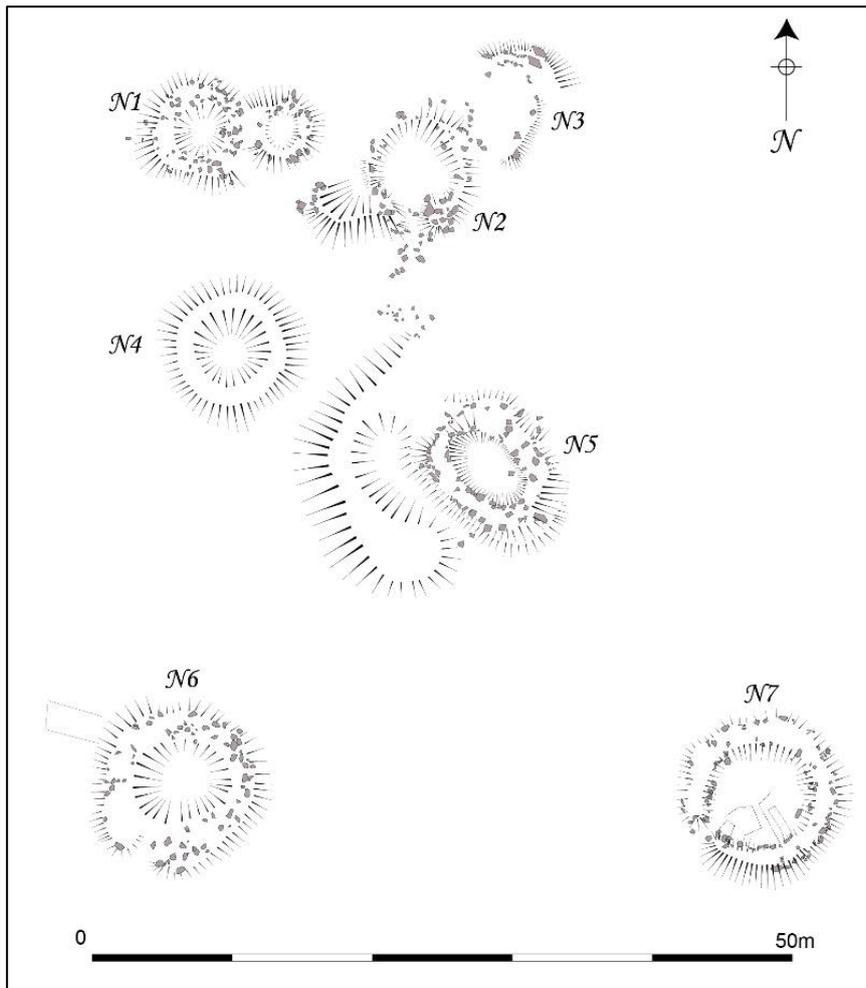
Fig 2. J.Gossip CAU 2024 survey of the northern group of roundhouses at Kynance Gate.

- Opportunity to increase interpretation through the Cornwall National Landscape website.
- Opportunity for significant scrub clearance of the northern group, informed by the CAU 2023 survey. This would require significant support and collaboration between landowner and volunteer groups and may include further agreement on the use of cool burns with the landowner Natural England and Historic England.

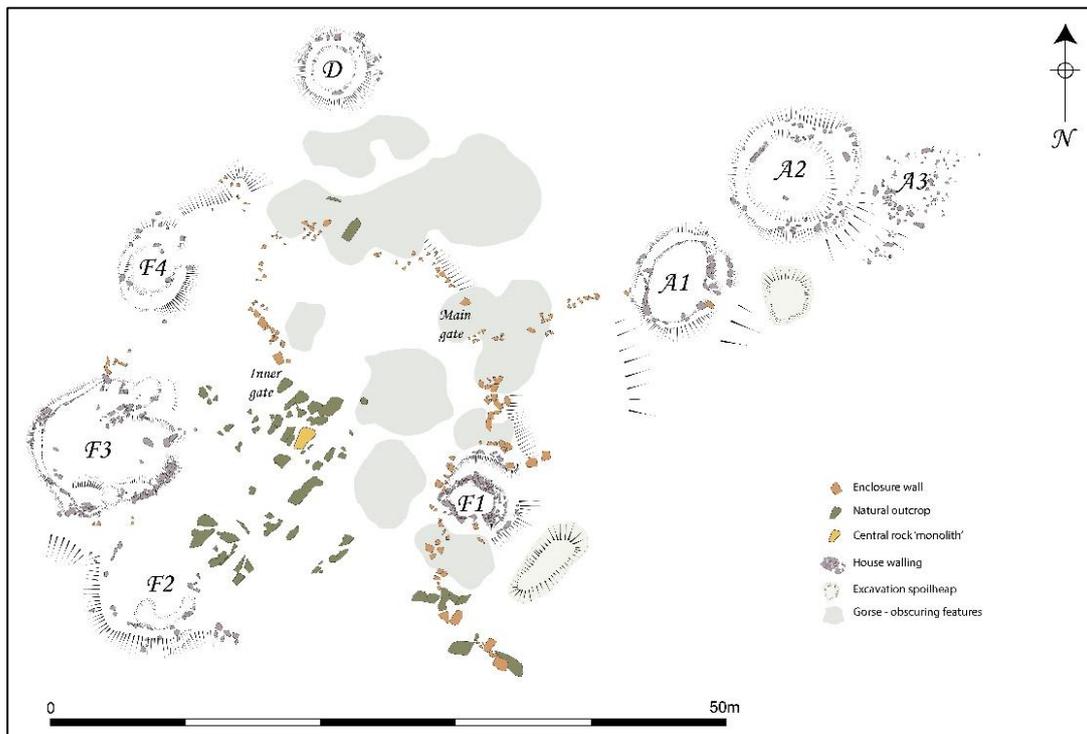
Fig 3. J.Gossip CAU 2024 survey of the southern group of roundhouses at Kynance Gate
