Nine Stones Circle Management Plan

## A Monumental Improvement Project

Cornwall National Landscape

# Nine Stones Stone Circle

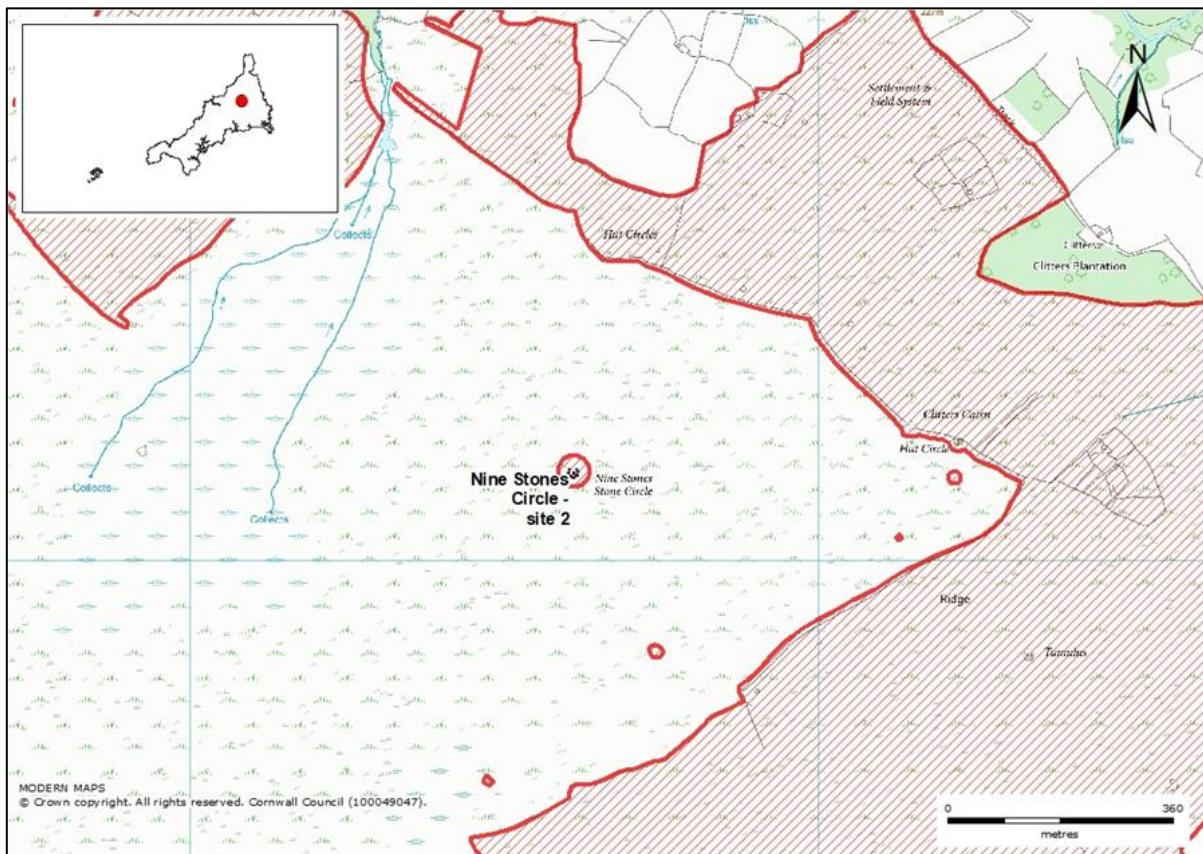
This stone circle is comprised of eight granite slabs, all of which are between 1-1.3m high and between 4-6.5m apart. 2 slabs are missing which has left a gap of 11.5m; one has been missing since the monument's depiction on an 1884 map, the other since 1889. A stone in the north-east section has collapsed outwards. A ninth erect stone positioned towards the circle's centre, is a relatively recent parish boundary stone.

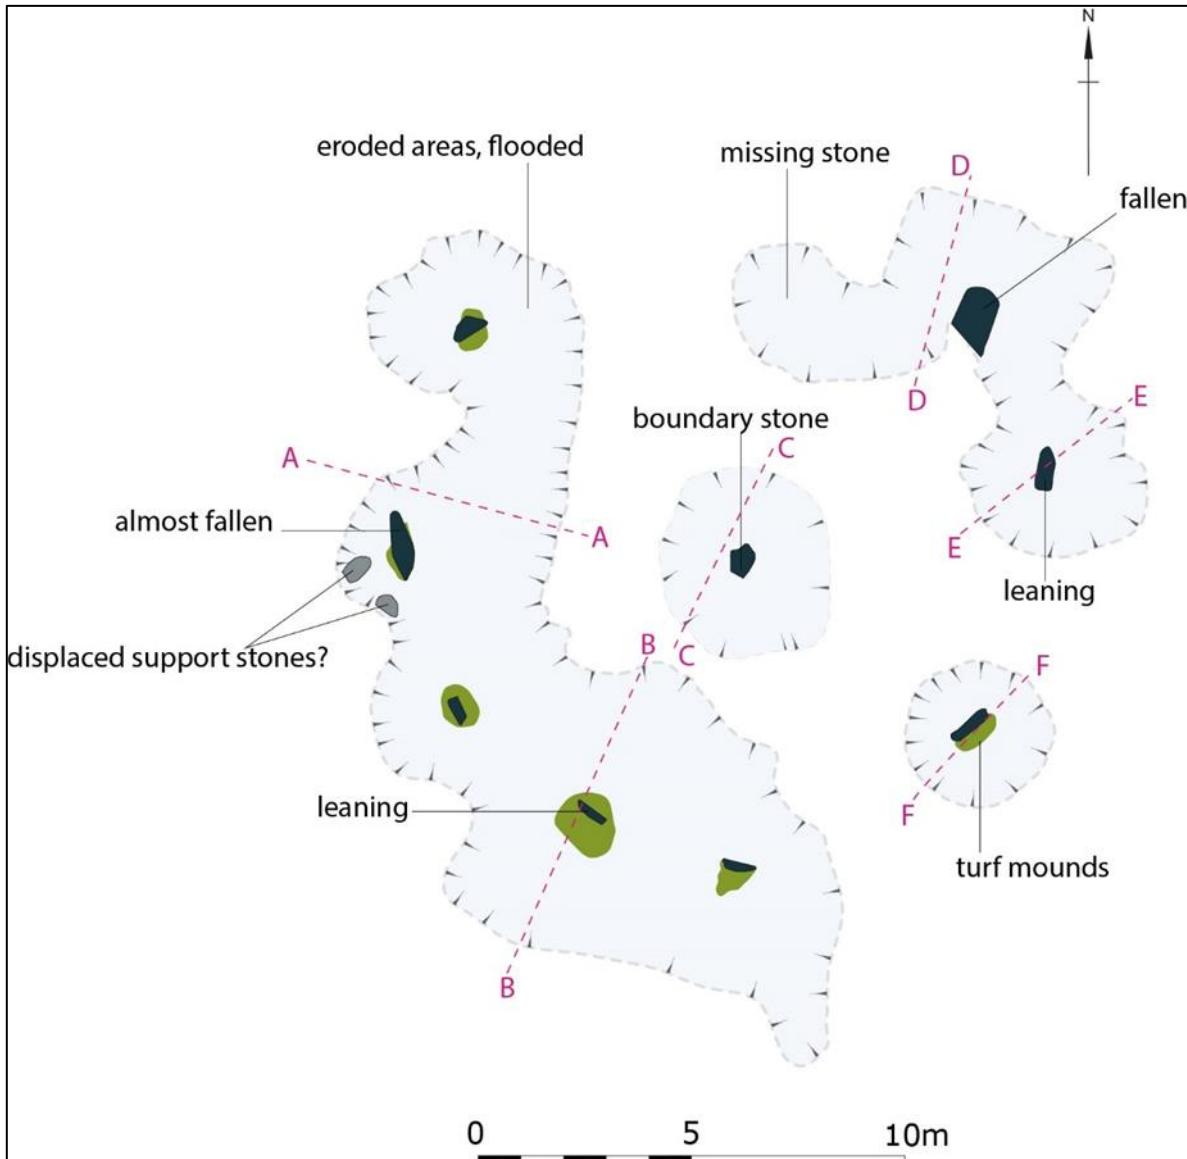
J. Gossip CAU: 2021 survey of Nine Stones

The stone circle is visible as a setting of eight granite slabs, ranging from 1m to 1.3m high and up to 1.05m wide by 0.35m thick, their bases spaced 4m to 6.5m apart about a near-circular course 15m in diameter (Barnatt 1982, 191-2). All of the slabs have eroded surfaces and edges, showing no traces of dressing. One slab has been removed from the circle since its depiction on maps of 1884, and

a second missing slab was noted in 1889, these leaving a gap of 11.5m in the northern sector. The site of one of these slabs is indicated by a surface hollow measuring 2m east-west by 1.5m north-south slightly within the circular course in its NNE sector. The northeastern stone has collapsed outwards but the remaining stones are erect, with packing stones and slabs visible about most of their bases. A ninth erect stone, situated slightly south east of the circle's centre, is a relatively recent parish boundary stone, one of a line of such stones that extends beyond the monument to the ENE and south west marking the boundary between North Hill and Altarnun parishes. This stone is 1m high, 0.35m wide and 0.22m thick, differing from the other slabs in having sharp angular edges and barely weathered surfaces.

- A project of conservation repair work was investigated by the Monumental Improvement Project in 2024 based on management proposals identified by CAU survey to address the waterlogged eroded hollows across the entire site, particularly surrounding each standing stone and re-erect two leaning and two fallen stones.

- The presence and size of the pools of water around the stone circle, compared with the survey in the archaeological overview of this document.
- Signs of scrub encroachment within the scheduled area.
- If site monitoring visits record scrub encroachment within the scheduled area, the Landowner with Relevant Volunteer Organisation support should manage and remove the vegetation in line with the guidance in the *Toolkit for Volunteer Monitoring and Maintenance at Heritage Sites* with due care to the ecological sensitivities in this document.
