St Constantine's Chapel and Well Management Plan

A Monumental Improvement Project

Cornwall National Landscape

September 2025

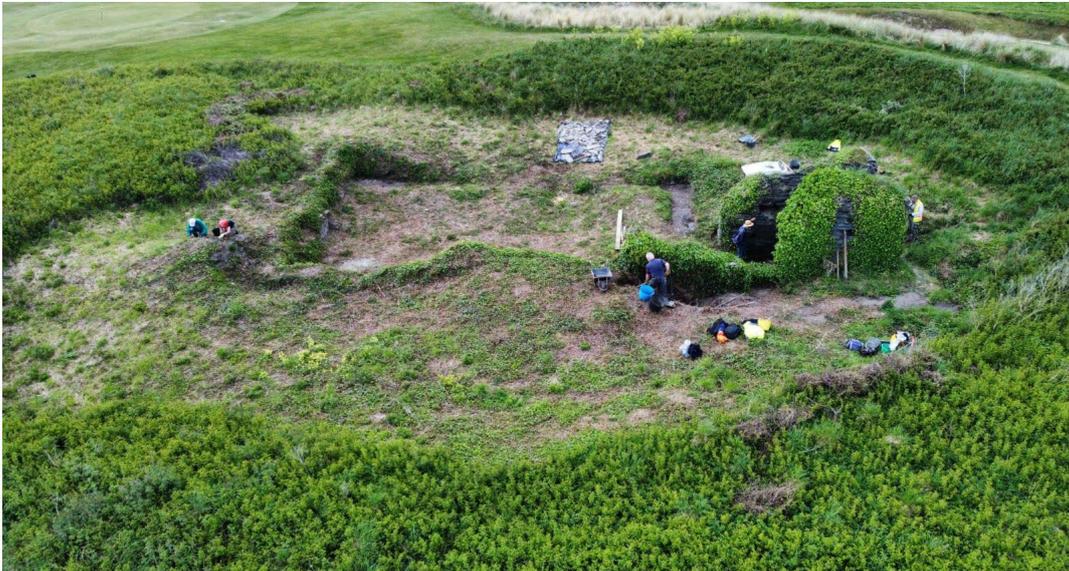
Figure 1 St Constantine's Chapel with buffer of cleared vegetation

- Vegetation should be cleared from the interior of the monument and 3 metres from the walls on the exterior of the monument (see image below) creating a vegetation free buffer.

- Brush cutters can be used on the majority of the monument, with hand tools required within 0.5 metres of the walls and tower to avoid damaging fragile features and stonework.

- Vegetation more than 3 metres away from the chapel should be left as habitat for the ecology, as well as provide shelter from wind and blown sand to the chapel.
